# REAR AIR SUSPENSION SYSTEM

*Chuck Garton-GMC Pacific Cruisers January 2, 2008*

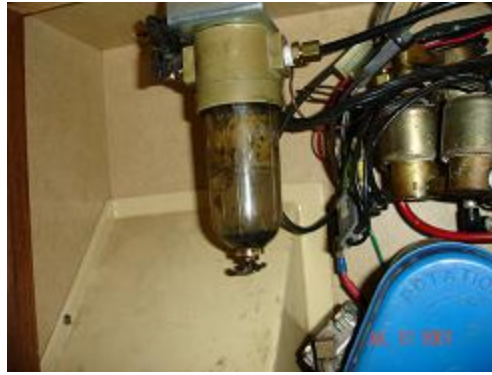
PICTURE 1

The next step was to install a 115VAC air compressor. The 1973 & 1974 GMC Motorhomes had wooden generator compartments that went to the back wall of the coach. There was enough room to mount the 115VAC compressor there. At that time, compressors and motors were separate items and the compressors had oil in them that required periodic maintenance. With access through the generator door, this was acceptable. I also found that running nylon tubing to the 115VAC Compressor would get hot and blow out. It was necessary to run a coil of copper tubing near the compressor. Copper tubing is hard to seal completely with compression fittings, however, this is not a problem because the leaks are very slow and only when the compressor is running. The line passes through a water filter (Picture 1) to a check valve where it enters the reservoir.

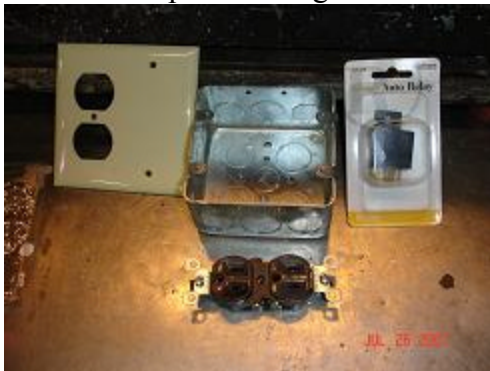
PICTURE 2

To control the 115VAC Compressor using 12VDC I used the parts shown in Picture 2. On the back wall of the

Motorhome was a 115VAC Romex line. I cut this and ran it through the metal box in Picture 2 connecting it to the top part of the receptacle. Picture 3 shows the "Bridge" cut on the "Hot" side only. The receptacle is mounted on the left side of the metal box and the relay (Radio Shack Part Number: 275-226) is mounted on the right side. The connections shown in Picture 3 are connected to the normally open connectors on the relay. The ground connector is connected to the receptacle ground (green wire). The 12VDC connector on the relay is connected to the unused connector on the air suspension pressure switch. The compressor is plugged into the switched (bottom) receptacle. Picture 4 shows the Completed Box.

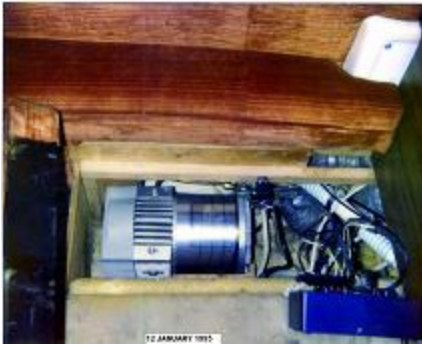
PICTURE 5

In the summer of 1993, I acquired a 1977 Kingsley and started the process all over again. In late 1974 the generator compartment was made of fiberglass and was sealed (Big improvement!) and ended with the end of the access door. The area I installed the 115VAC Compressor on the 1974 coach was still there, but is now accessed from inside the

coach (Picture 5). 115VAC Compressors have improved and the motor and compressor are now one piece with Teflon moving parts requiring no oil and no drive belts. Except for the inlet air filter (Picture 6), it is maintenance free.

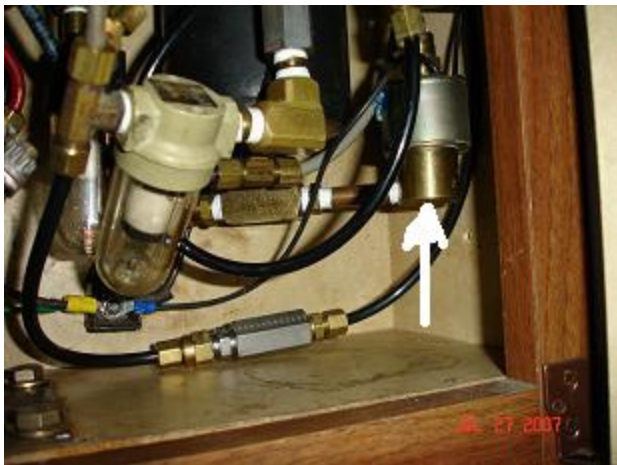
PICTURE 7

To install air bag pressure gauges in the Kingsley, I had to run three air lines to the dash. I also installed the electro level valve in place of the Schrader valve in the reservoir (Picture 7 arrow). I installed two dual pressure gauges (Picture 8). The forward (green) needles are the air bag pressures and the rear (red) needles are the reservoir pressure.

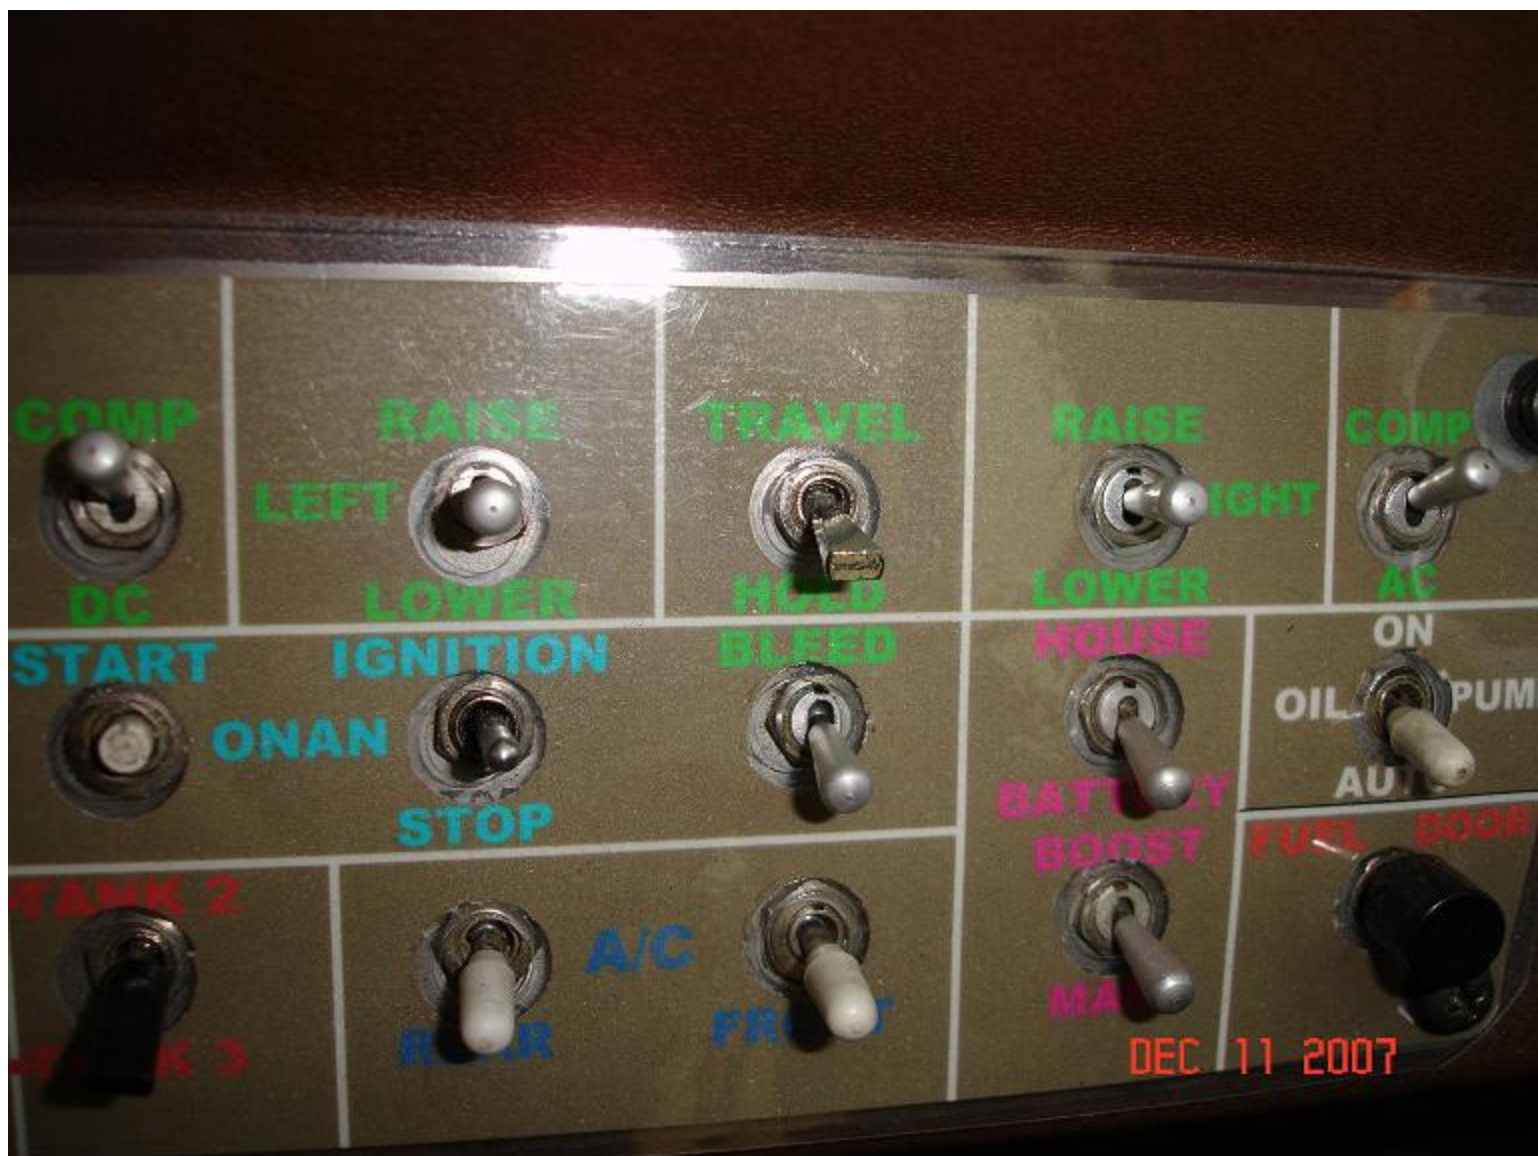
PICTURE 9

To control the system are six switches [Picture 9 (Top 5 and the “Bleed” switch below “Travel/Hold switch”)] and three lights (Picture 10).

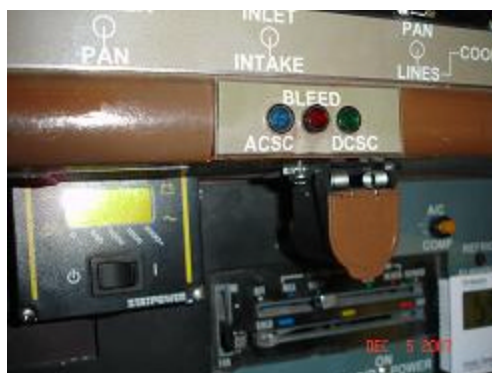
PICTURE 10

Picture 10: **ACSC** stands for 115V**AC** Suspension **C**ompressor; **DCSC** stands for 12V**DC** Suspension **C**ompressor.

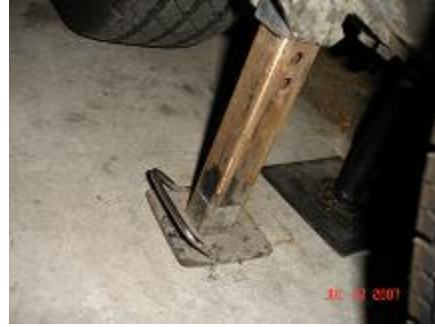
PICTURE 12

I have installed rear support jacks with built-in J Hooks (Pictures 11 & 12); I obtained from Pat Cerrina at the Temecula Western States Rally. Now, the only time the air bags are inflated is when I'm traveling.

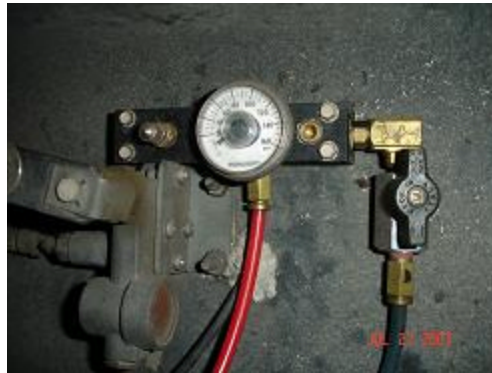
PICTURE 13

I installed a set of Dave Lenzi's air manifolds (Picture 13). I like these because they mount on the fender well instead of hanging on the air bag. The red tube goes to the air bag, the black line to the electro-level system.
